# Ice House Log Hazards

May 21, 2022

410 cfs

Documented By Jeff Wasielewski

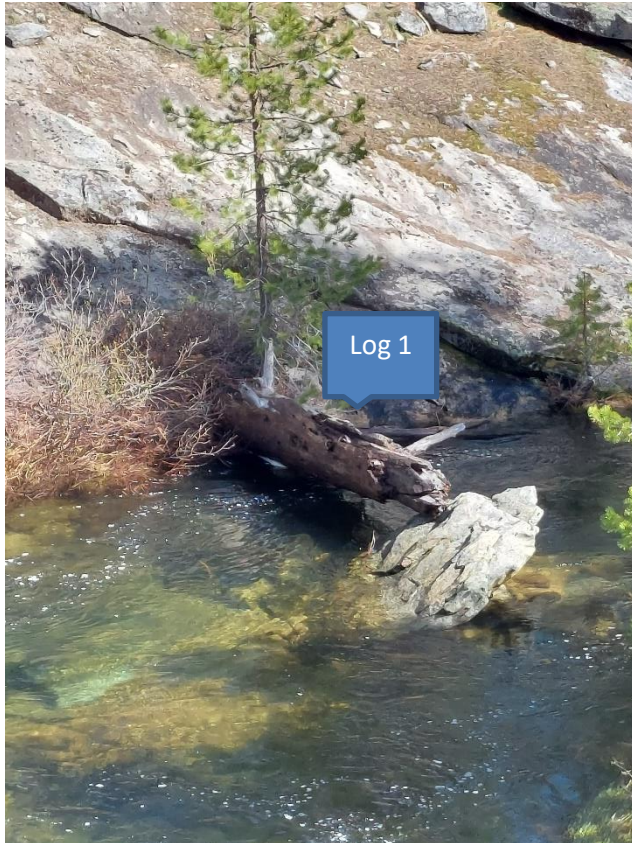
Log 1 – This log is located on the upper portion of the run with easy access. It is located directly below a rapid that sometime causes swims. Please note that this picture was taken after the release was completed on 5/21/22.

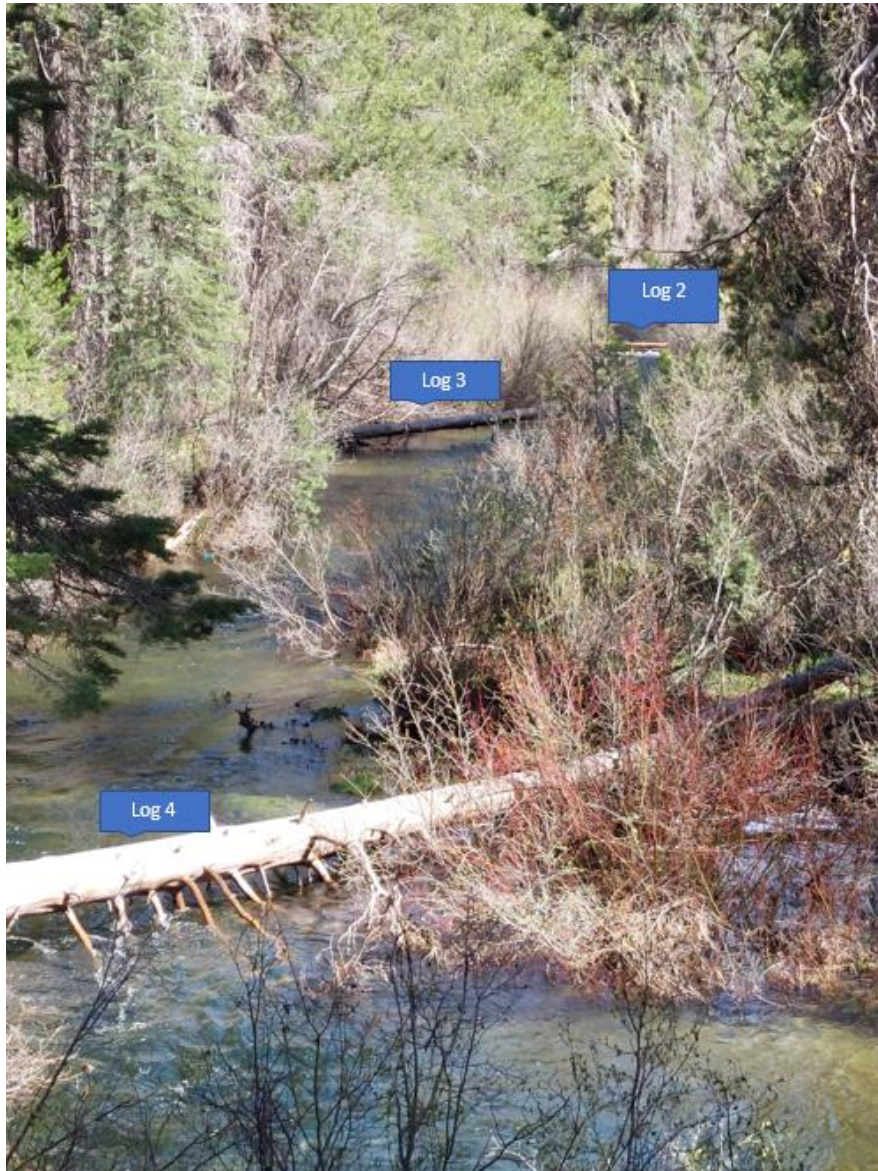
Logs 2, 3, and 4 – These three logs are located just upstream of the bridge adjacent to the campground. They are the main reason the portion of the run above the bridge is skipped by some (including me). There is easy access to all three logs. Please note that this picture was taken after the flow had dropped on 5/21/22.

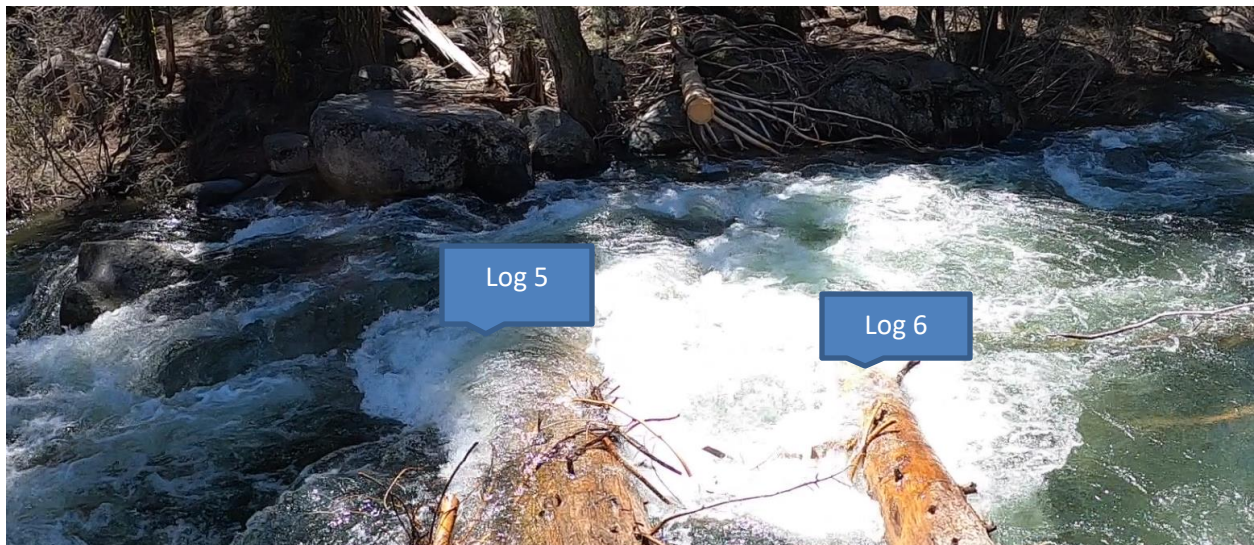
Log 5 and 6 – Although much better than it used to be, the two remaining logs on the right are still a hazard. This is especially true because log 6 is not visible from above and at 500 cfs a kayaker could make a dangerous mistake by going over log 5 and then being pinned by log 6.

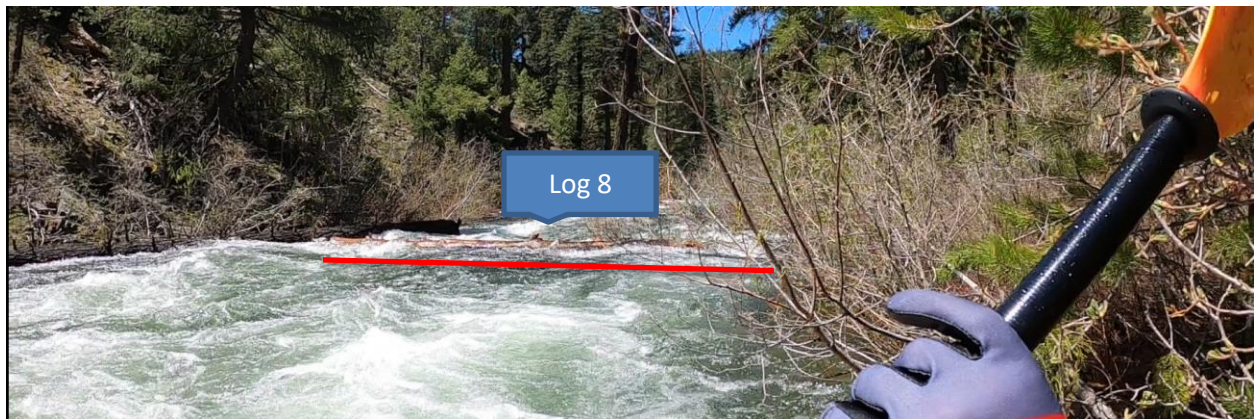
Log 8 – Located about 150' below the second drop of Triple Drop, this log is the most hazardous one on the run. This is because it is not visible from above and by the time you identify that it is there it is too late. Also, it is an extreme hazard for any swimmers that swim at the second drop of triple drop, and swims there are common.

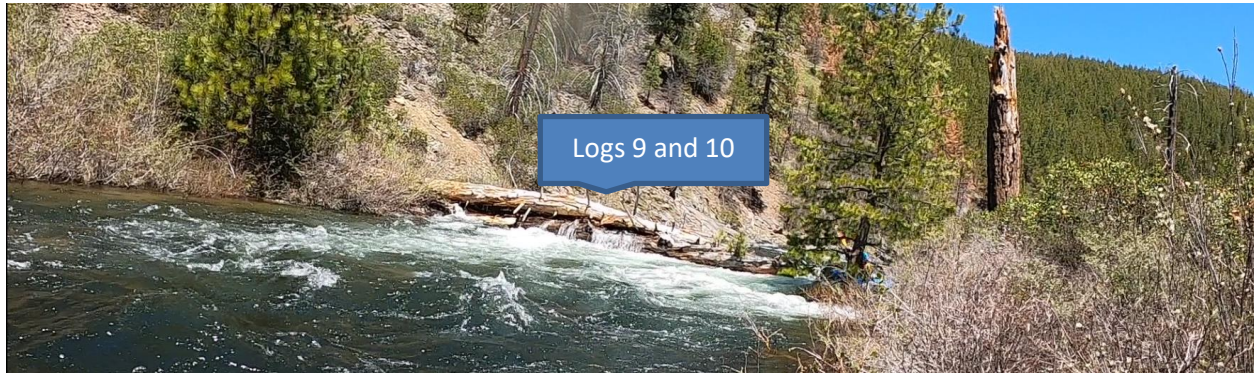
Logs 9 and 10 - Two logs that are stacked on each other in swift water. Very hazardous.

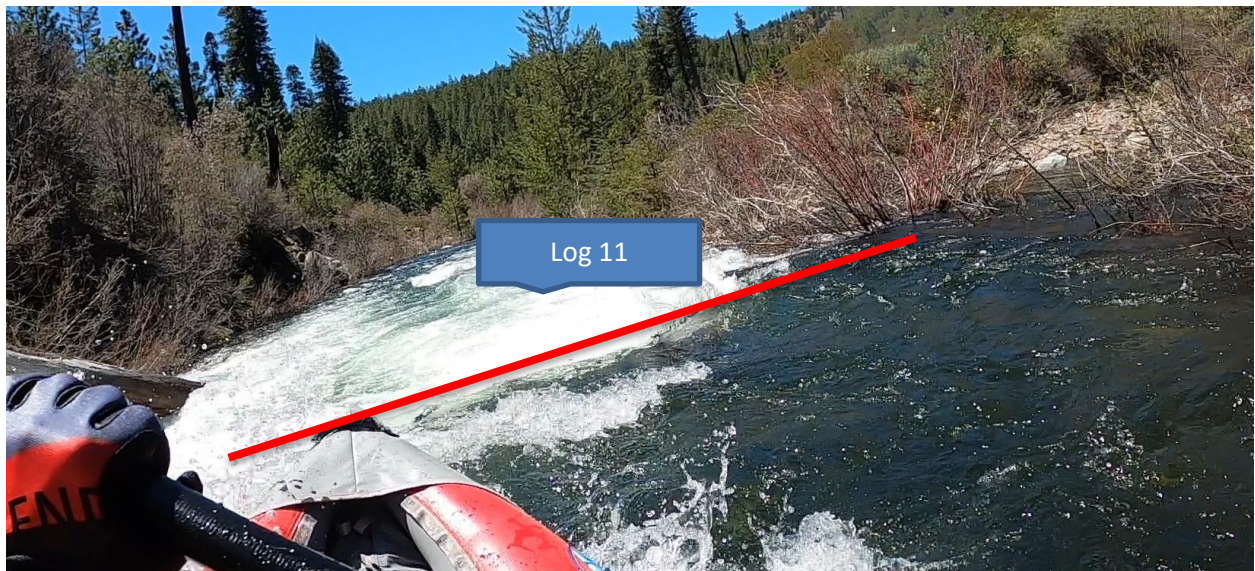
Log 11 – This picture was taken on 5/14/22 at 485 cfs. At 410 cfs it is more exposed. The log is across the entire channel.

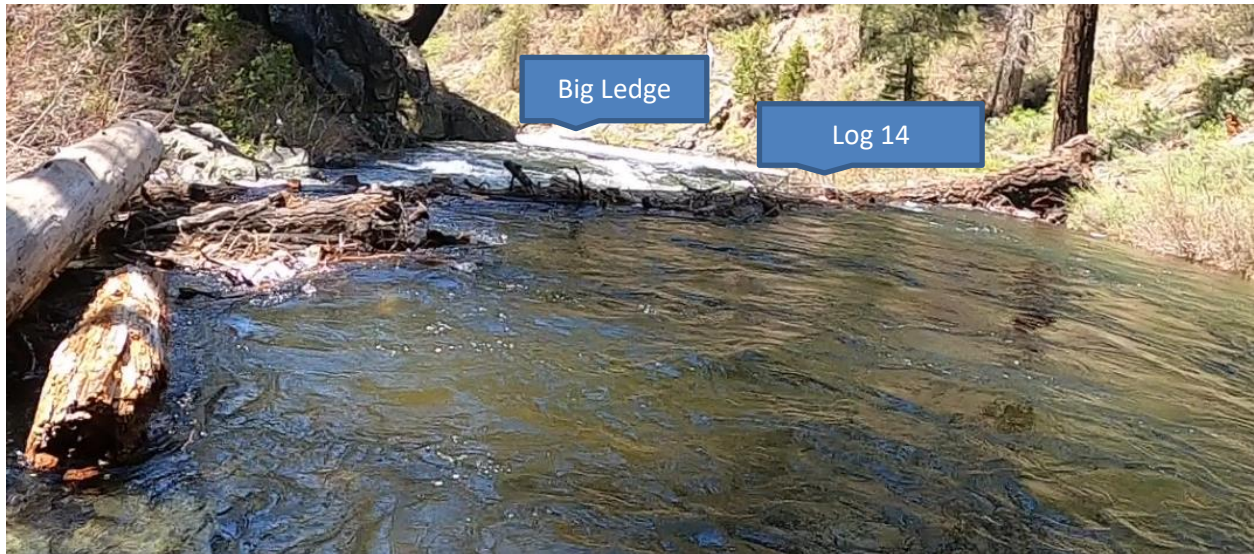
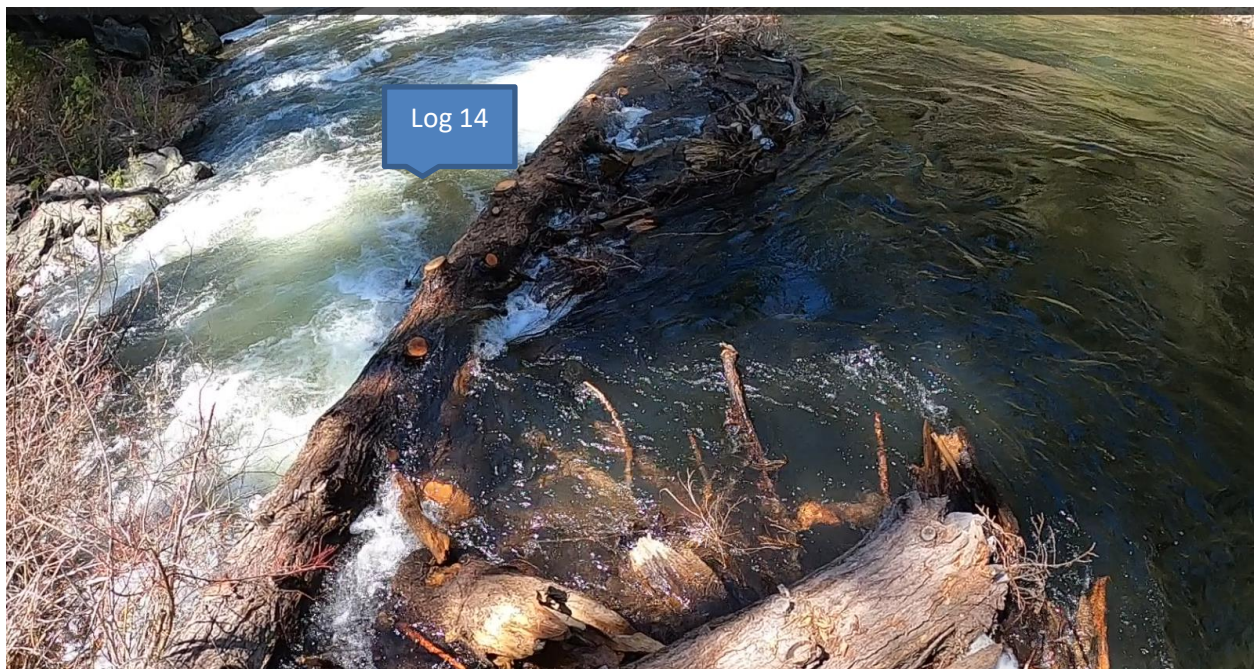
Log 14- This log is problematic for hardshellers since it is difficult to get safely back into the water. A large rapid (Big Ledge) is located directly downstream. Ideally the left half of this log would be removed. If that is not feasible then having the top 12" of the log removed in a 15' wide channel on the left would help with safe passage.
